Statement of Performance

Furon[®] HPVM, 2-Way (Mini) Valve Cycling Test

An accelerated life test was conducted on Furon HPVM2 (mini) valves which were subjected to 1,000,000 cycles.

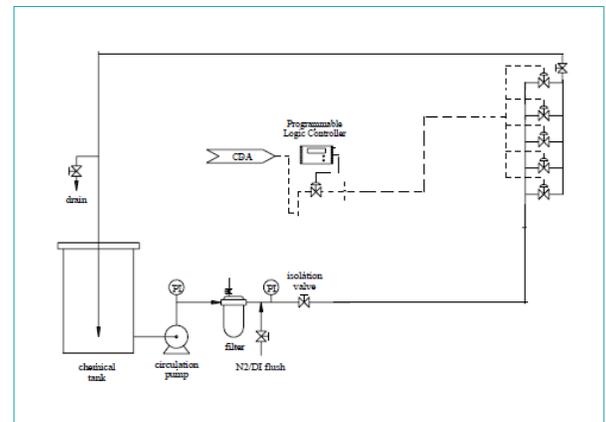
Figure 1

Five Furon HPVM, 2-way valves were assembled in a manifold set (**Figure 1**). Each valve was cycled 3 seconds open and 3 seconds closed at room temperature with an actuator pressure of 70 psig. The pressure of the deionized (DI) water running through the valve was set at 80 psig. At regular cycle intervals the valves were removed from the manifold and examined to ensure they retained pressure capabilities and performance integrity.

Throughout the test the valves were evaluated for cracking pressure and internal leakage. Internal leak testing was conducted by positioning the valves in a vertical orientation with the test ports down. Degassed ultrapure water then flowed upward through the valves. The valves were opened and closed several times and agitated to evacuate air bubbles. The valves were then left closed. The downward facing test ports were drained of water and pressurized with clean dry air CDA. The upward facing ports were plumbed to a bubble trap to monitor any air leaks past the seat. This procedure was repeated for both the inlet and outlet ports of each valve in agreement with the pressure requirement of 100 psi for the forward pressure and 80 psi for the back pressure. Crack pressure testing was conducted by plumbing a variable pressure CDA supply to the test port of a closed valve, and a pressure gage to the other port. CDA pressure was slowly increased to a maximum of 100 psi, or until the pressure gage at the other port increased, indicating a bypass. The CDA pressure required to cause the bypass was then recorded.
